REPORT OF SUBSURFACE EXPLORATION
AND WELL INSTALLATION
PELHAM PHOSPHATE COMPANY
PELHAM, GEORGIA
LETGO JOB NO. CO-818

SKETCH of OUTSIDE WASTE PILE AREA
PELHAM PHOSPHATE COMPANY

Site Analysis
Stoller Chemical/Pelham Phosphates Company
Pelham, GA

**SHEETPILE/TOP CAP INSTALLATION
STOLLER CHEMICAL SITE
PELHAM, GEORGIA**

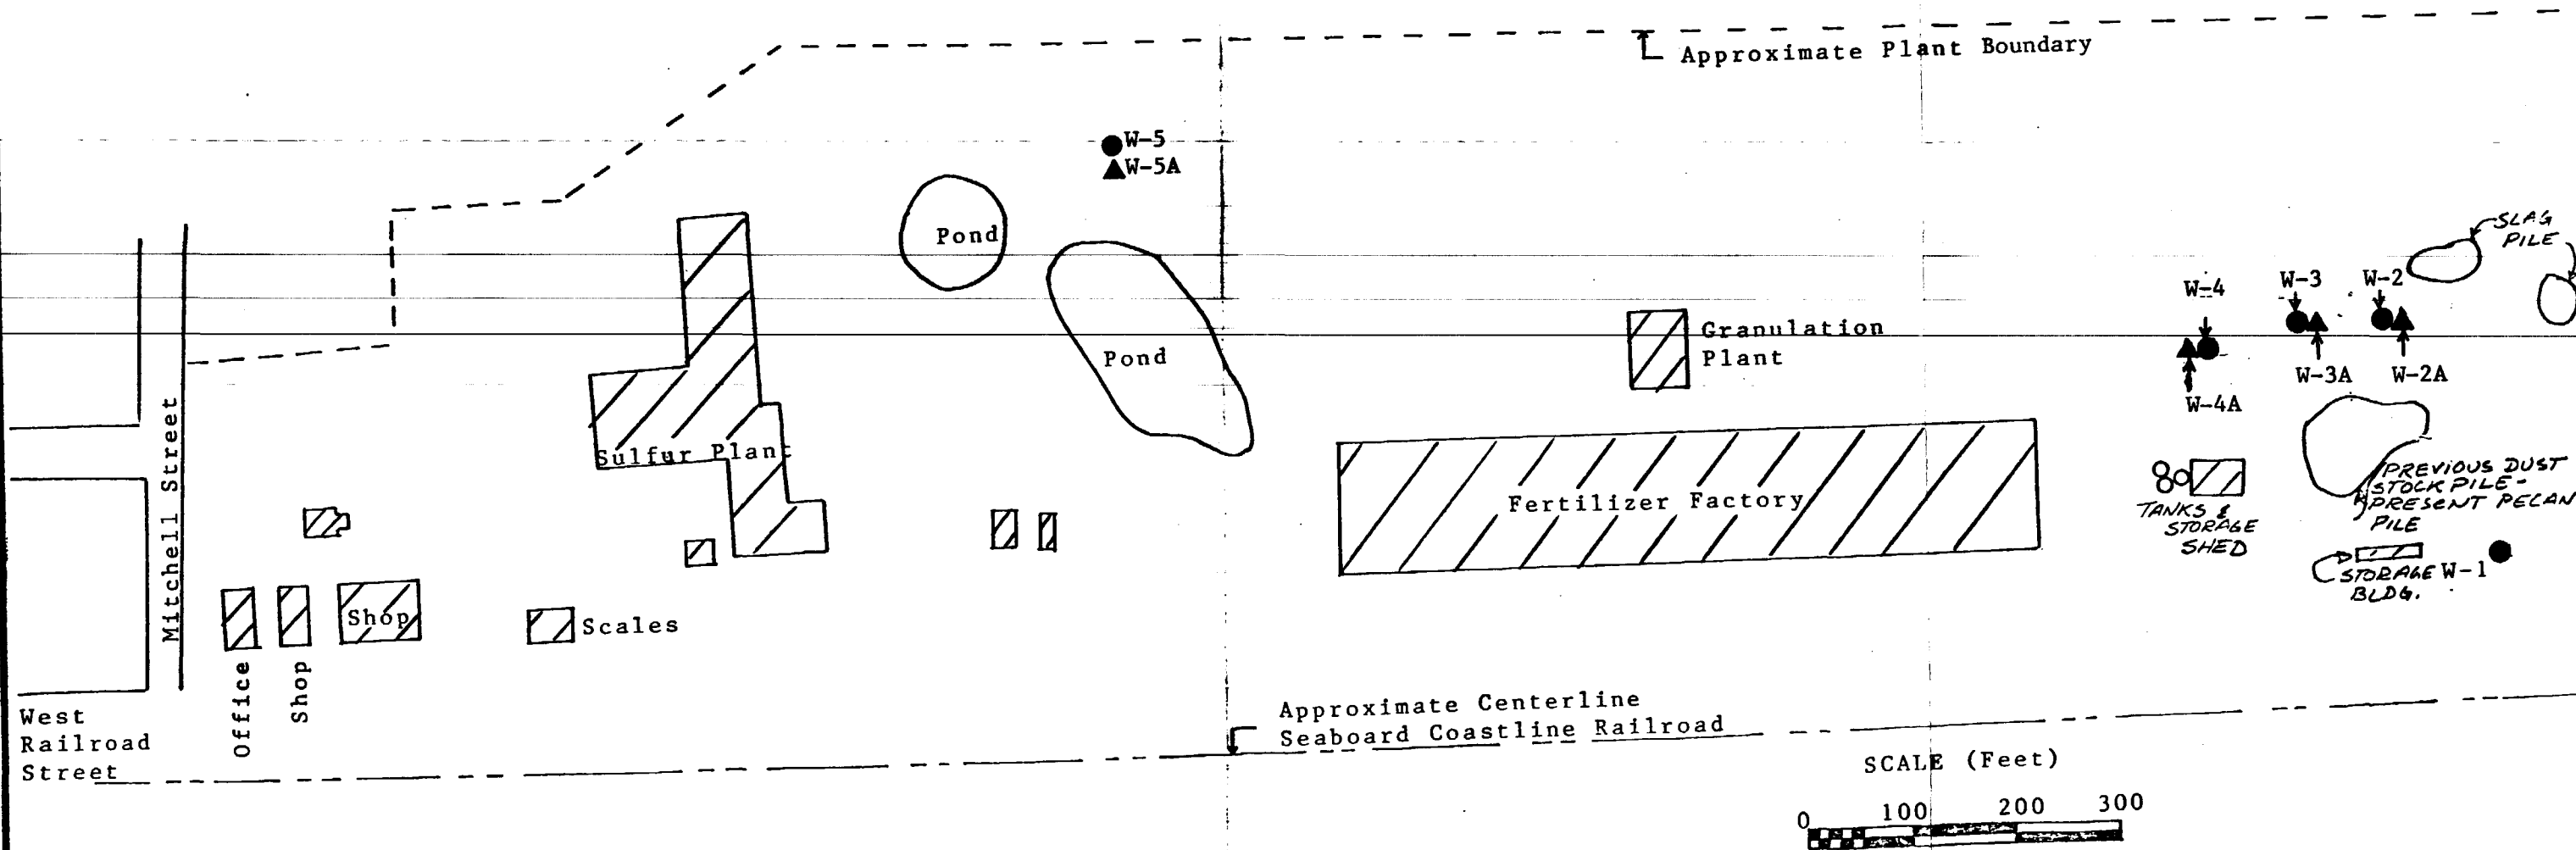
- Soil Test Boring/Monitoring Well Locations
(LETCO Report Dated October 18, 1983)
- ▲ Replacement Well Locations
